# Characterisation of Vibrations of a Precast Reinforced Concrete Bridge:

## *The Case of Kangundo Road Bridge on Outering Road, Nairobi, Kenya*

\*Clive Mukiria Muita, Simpson N. Osano and Sylvester O. Abuodha

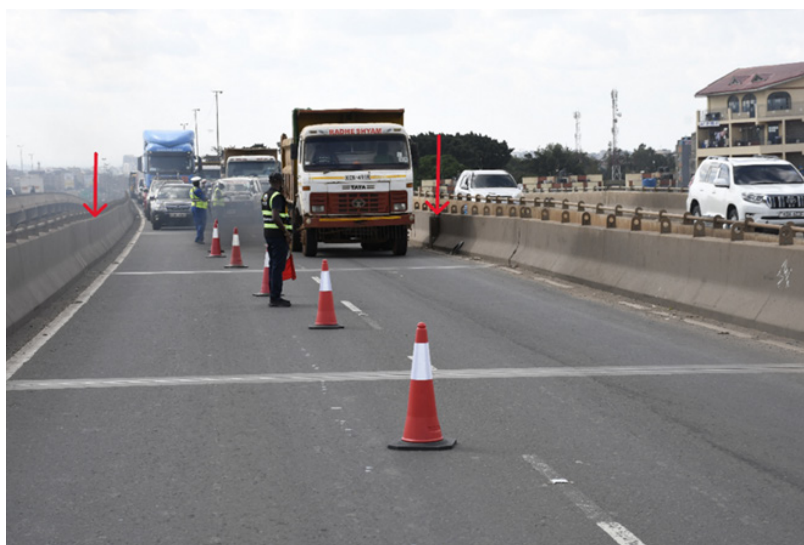
**FIGURE 1**

Deflection profile of the Kangundo Road bridge

The Kangundo Road Bridge in Nairobi, Kenya, has developed permanent mid-span deflections that are inconsistent with the initial design, as shown in **Figures 1** and **2**. Such deformations are likely to alter the bridge's dynamic behaviour. While visual inspections can identify physical defects, they do not, however, quantify dynamic performance or user experience. In Kenya, there is limited data on bridge vibration levels and compliance with established worldwide comfort limits. Additionally, the effectiveness of affordable, off-the-shelf accelerometers in monitoring real-world bridge vibrations remains underexplored. The paper investigates bridge vibrations through the lens of acceleration measurements, exploring their role in characterising vibration levels and comparing them with worldwide best practices.

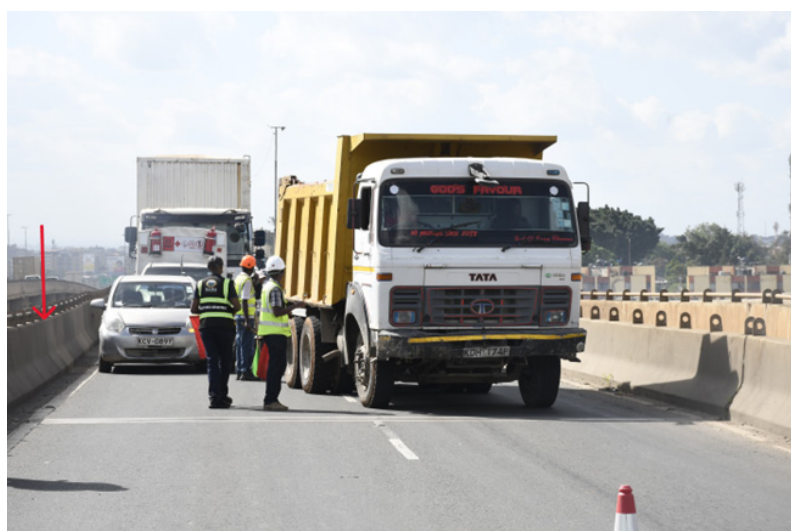
**FIGURE 2**

Deflection profile of the Kangundo Road bridge

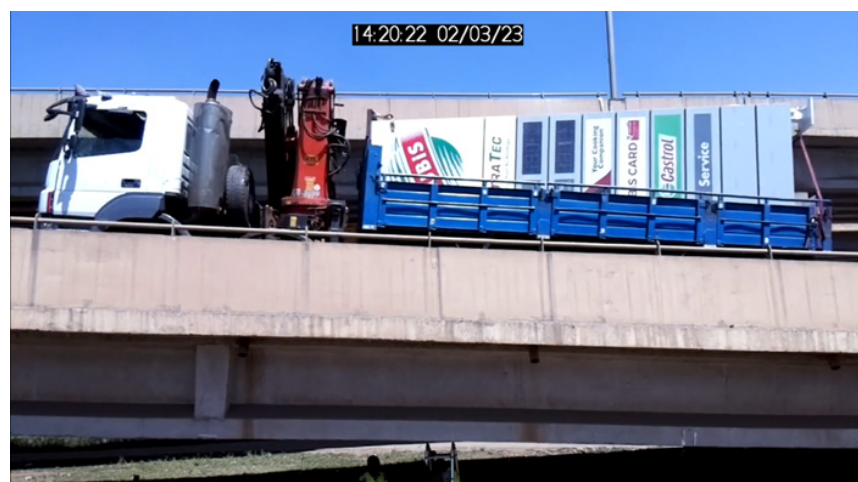
**FIGURE 7**

Four-axle HGV during ambient traffic testing

HGV in **Figure 7** caused accelerations that were 87% to 110% above the threshold recommended by Wright and Walker. The vibrations from the HGV surpassed the ISO 2361 comfort limits for all sensors by between 49% and 73%. Similarly, sensors S1 to S5 exceeded the AISC threshold of  $0.491 \text{ m/s}^2$  by between 4% and 18%, as shown in
