# Challenges Faced in the Implementation of Planned Safety Measures in Mega Infrastructure Projects: *A Case Study of Road Safety on Thika Superhighway*

Gladys N. Maina\* and Isabella N. Wachira-Towey

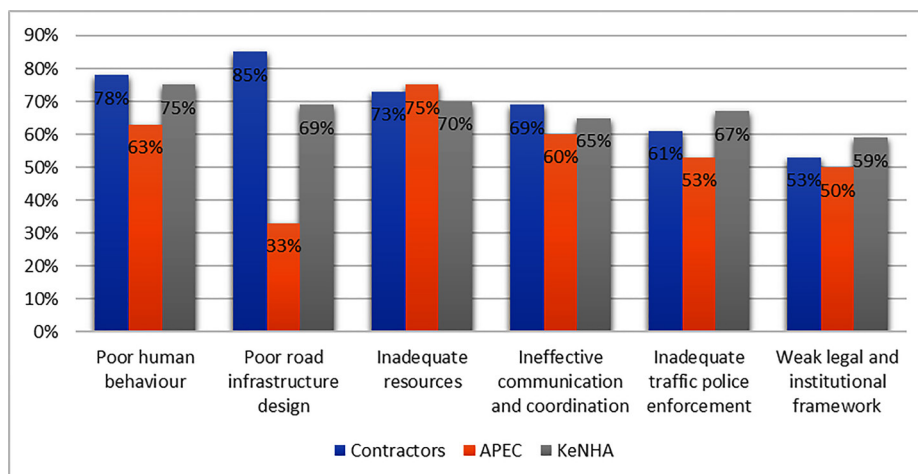
**FIGURE 2**  
Challenges faced by Employer, Design Engineers and the Contractors  
Source: Field survey 2015

The main findings of the study can be summarized as shown in **Figure 2**. The main challenge faced by the Contractors, Employer and Design Engineers in the implementation of the planned safety measures was poor road infrastructure design (**Figure 2**). People with disabilities, such as the blind and disabled, were not taken into consideration in the design and implementation of the project. This made it difficult for the disabled person to cross from one side of the highway to the other without risking being knocked down by speeding motorists. Moreover, there were no

space provisions for cars that broke down or ran out of fuel while on the highway and needed to pull aside to fix the problem. The footbridges were also far apart which tempted pedestrians to cross the high speed highway at non-designated areas. Speed bumps/zebra crossings were located next to footbridges hence confusing pedestrians on which one to use. Bus stops were not provided with enough space forcing buses and 'matatus' (minibuses) to pick and drop passengers at the main carriageway and the bus stops were located away from where people were coming from. Hand cart pullers were not accommodated on the cycle lanes forcing them to use the main carriageway. This is illustrated on **Plates 1** and **2**. Poor infrastructure design was further attributed to the lack of accurate data on road safety matters. This meant that at times, the contractors had to redo the work to capture emerging safety issues which had not been envisaged earlier in the design, hence incurring additional cost and time for the project. Poor infrastructure design was also cited by Asingo & Mitula (2007) as a challenge in the management of road safety.

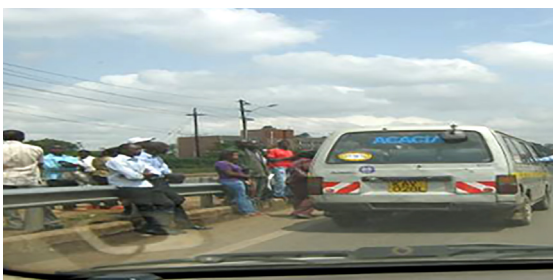
**PLATE 2**

Buses stopping on the main carriageway

The various resources required for the implementation of the road safety measures should also have been considered during the planning phase of the project, for example, the availability of space/land to accommodate the various safety measures such as bus stops, footbridges, cycle lanes, physical design etc. should have been considered. This is so because even though bus stops were provided, they had inadequate space forcing buses and 'matatus' to pick and drop passengers on the main carriageway further compromising on the safety of the road users.

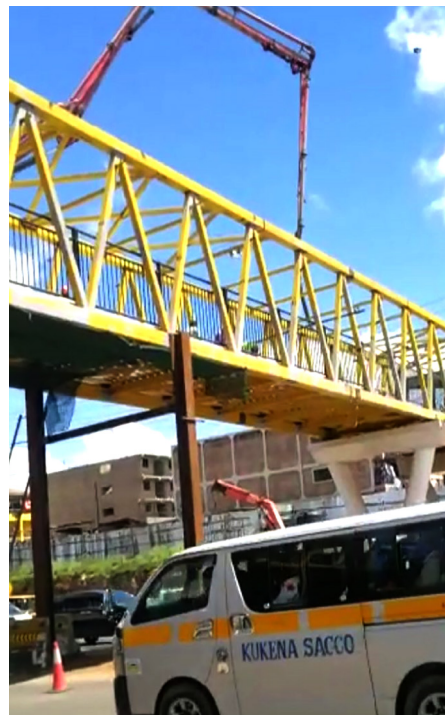
**PLATE 3**

Since completion of the highway, only four additional footbridges have been constructed at Witeithie, Njomoko (Mang'u), Survey of Kenya and Garden City (Garden Estate Junction) despite the frequent accidents involving motorists and pedestrians. The total number of footbridges now stands at 18 with 10 more designed but yet to be erected due to lack of funds. There has also been construction of additional service roads and bus bays on each side of the road to ensure passenger and pedestrian safety. This is in addition to removal of existing speed bumps and restoration of the road surface at those sections. The construction of the additional footbridges has brought massive traffic snarl ups. A case in point is during the erection of the Witeithie footbridge which interrupted traffic flow at Witeithie as a result of poor traffic management (**Plate 3**).

Witeithie footbridge

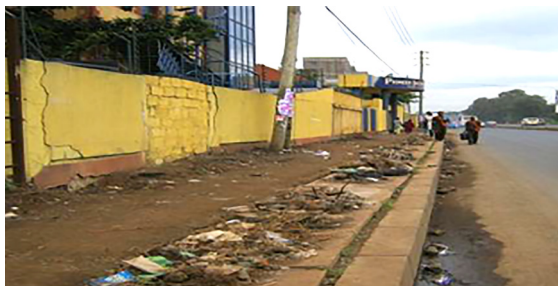
Poor human behavior can further be attributed to the failure by the planners to plan for and implement road safety awareness programmes and also failure to involve the residents during the planning phase of the project meant that they didn't 'own' the project. Ngeso (2009) cited poor human behavior as a challenge in the management of road safety. The clutter on the sidewalk means insufficient space for pedestrians. Lack of maintenance has the same effect as if the sidewalk was not present. Poor human behaviour is illustrated on **Plates 4** and **5**.

**PLATE 4**  
Carriageway along Muthaiga Roundabout to Uhuru Highway zone  
**Source:** Field survey 2015

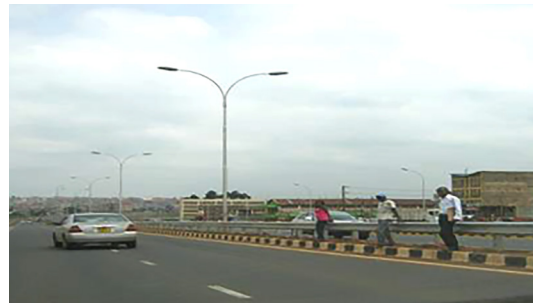
**PLATE 5**  
Pedestrians crossing at non-designated areas  
**Source:** Field survey 2015
