Evaluating the Performance of Bitumen Emulsion Stabilized Bases in Low Volume Sealed Roads:

A Case Study from Kiambu County (E443 Road)

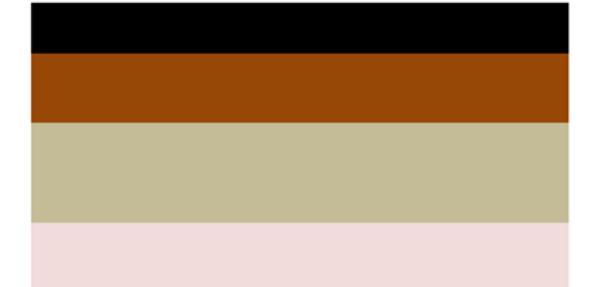
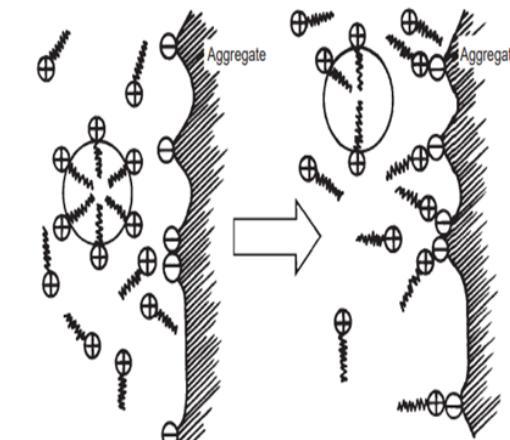
FIGURE 2 Emulsifier Micelles in a Stable Solution and Breaking Source: Salomon, 2006

Emulsion charge on droplets prevents close approach.

Stages in the Breakdown of Emulsions

Flocculation: Close approach of droplets leads to adhesion between droplets. Water is squeezed out.

Coalescence: Water drains between droplets and surfactant film breaks down; droplets fuse, trapping some water.

Coalescence: Trapped water diffuses out.

Salomon (2006) in Transportation Research Circular E-C102 for Asphalt Emulsion Technology indicated that bitumen emulsion sets or breaks the moment it is in contact with either the soil sample, road surface or aggregate as illustrated in Figure 2.

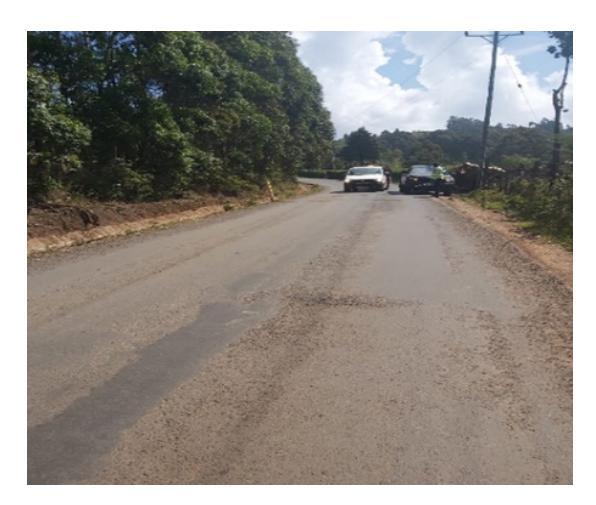
a) Intact section with lined drains at km 2.3

FIGURE 4a&b E443 Road Condition Source: Nzai, 2025

Figure 4 shows the road drainage and surface condition. Generally, the intact sections were

noted to have working drains whereas potholes and interconnected cracks were observed in poorly drained sections. In most sections of the road, the drains were either non-existent or blocked, contrary to the provisions of Ministry of Transport and Public works (1986) that requires drains to be well shaped and free flowing. The optimum moisture contents (OMC) for sub-base and subgrade varied considerably and this could be attributed to the poor drainage condition. Further the cracked and pot holed road surface may have allowed ingress of water into the BESM base. This uncontrolled moisture ingress to the base from the road surface and the drains would definitely affect the BESM base performance. BSM 3 material is quite sensitive to moisture levels and this could explain the reason as per why the soaked ITS sample crumbled under testing.

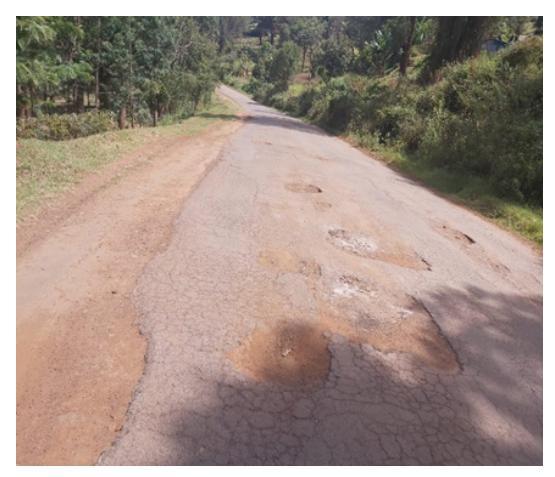
b) Cracks, pot holes and no drains at km 3.5

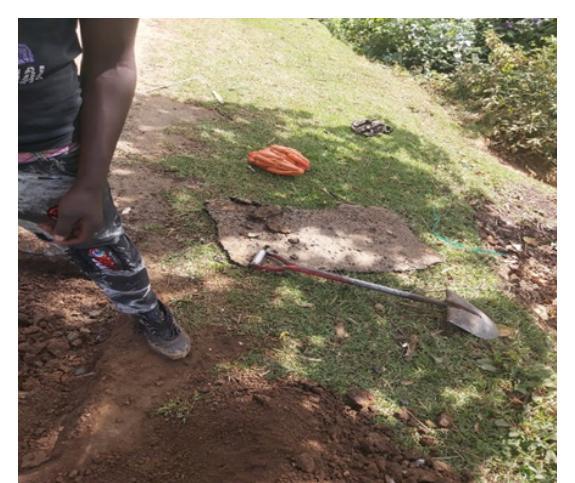
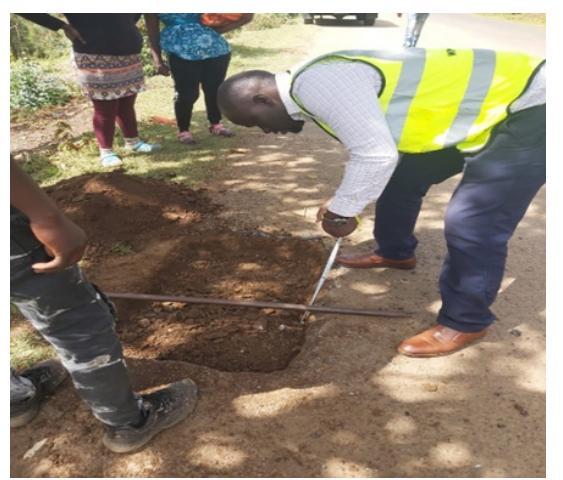
a) Milled cold AC surfacing
FIGURE 5a&b
Extraction and Logging of AC Surfacing
Source: Nzai, 2025

b) Surfacing thickness measurement

Trenching and sampling of base, subbase and subgrade materials were carried out in accordance to Ministry of Transport and Communications., (1987), Road Design Manual Part III Materials and Pavement Design for New Roads, Kenya. The surfacing material was extracted by milling off the asphalt concrete layer and sampled for testing as per AASHTO Designation T 168-96: Sampling of Bituminous Paving Mixtures, **Figures 5 a&b**.

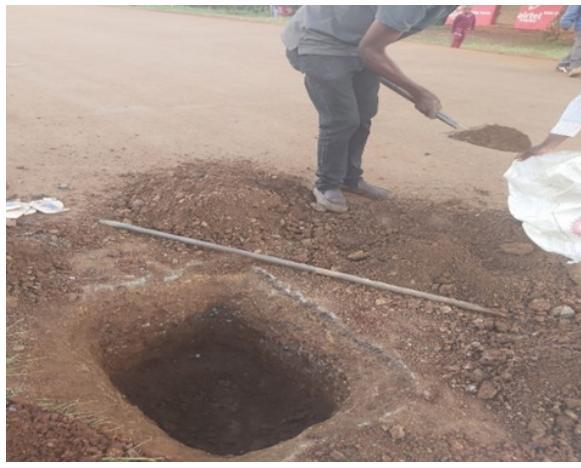
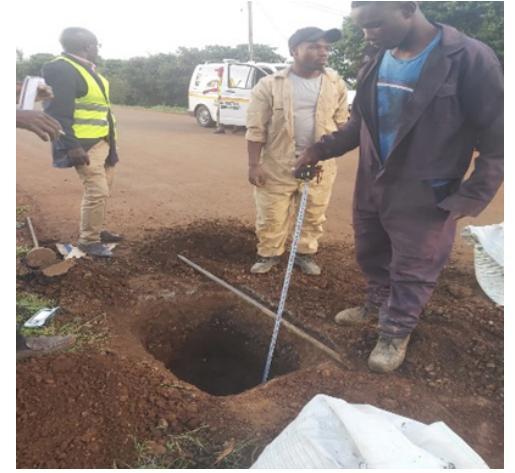
FIGURE 6a&b

a) Sampling of excavated pavement material

Sampling and Logging for BESM Base, base and subgrade **Source:** Nzai, 2025

b) Layer thickness measurement

A trench of 1m length by 1m width by 1.2 m depth was dug at the road edge at 1km interval to extract the pavement materials. The nature of each pavement layer was established and thicknesses measured. Excavated materials were sampled separately for BESM base, subbase and subgrade in polythene bags. **Figures 6 a&b** shows the

sampling of materials and determination of the as-built pavement thicknesses.

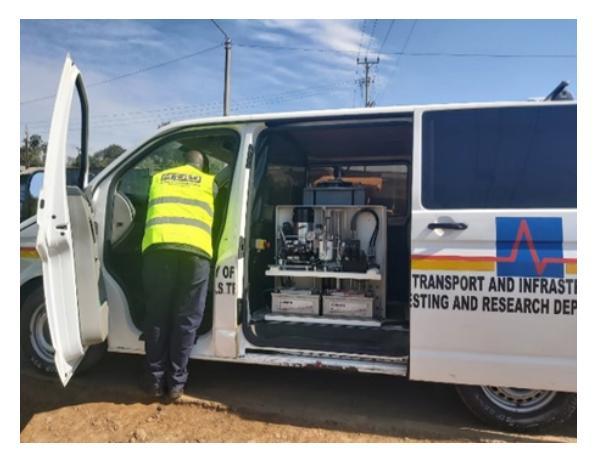
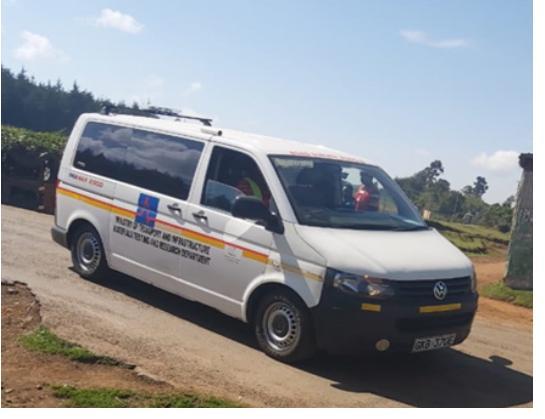
a) Van Integrated FWD Equipment
b) E
FIGURE 7a&b
Non Destructive Testing for Deflection measurements
Source: Nzai, 2025

b) Deflection Measurement

The road deflections were measured using the Primax 2500 model Falling Weight Deflectometer (FWD) equipment, **Figures 7 a&b**, that meets requirement of ASTM D4694 - 09, 1996 and ASTM D4695 - 03, 2008. The deflection measurements were conducted in an alternating manner on both lanes at intervals of approximately 100 m on the Outer Wheel Path (OWP) at an offset of about 0.7 m from the edge of the carriageway. At each drop point, raw deflection (rd) readings were taken for the nine (9) consecutive geophone points of 0, 20, 30, 60, 90, 120,150, 180, and 210 cm. This non-destructive testing of the pavement was done to establish the current performance levels in terms of layer elastic modulus, pavement residual life,

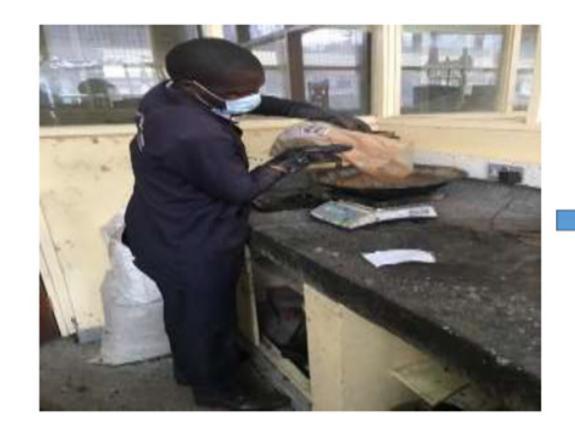
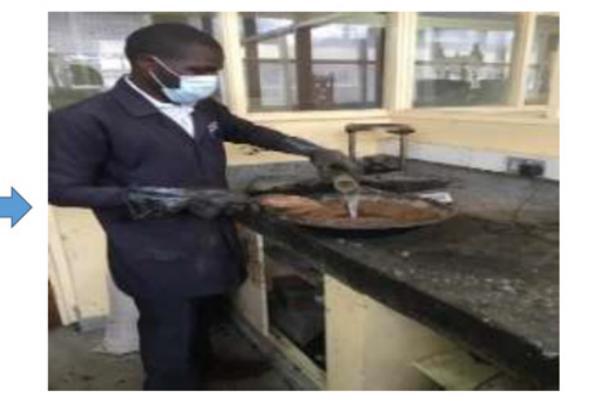
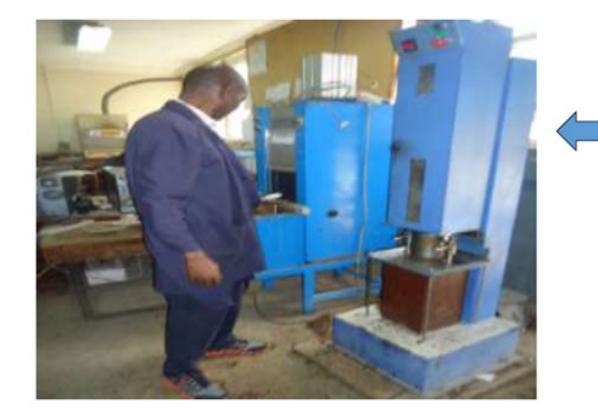
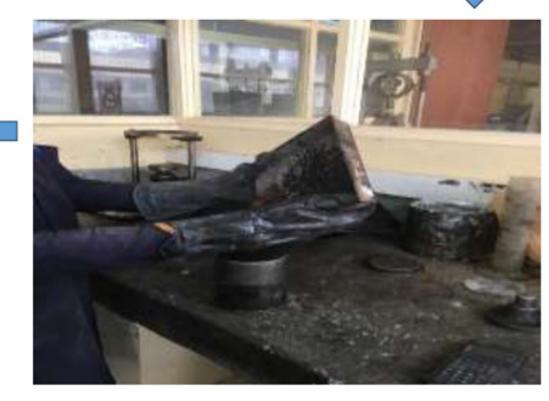
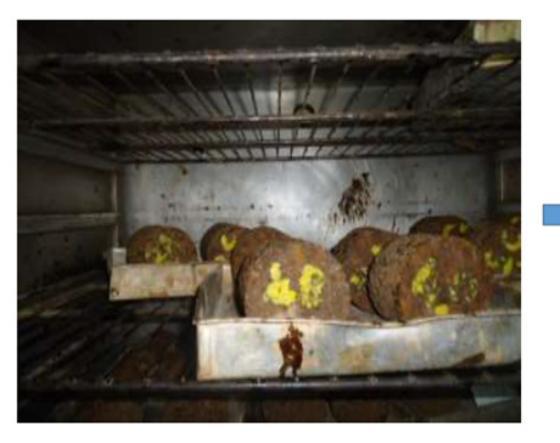
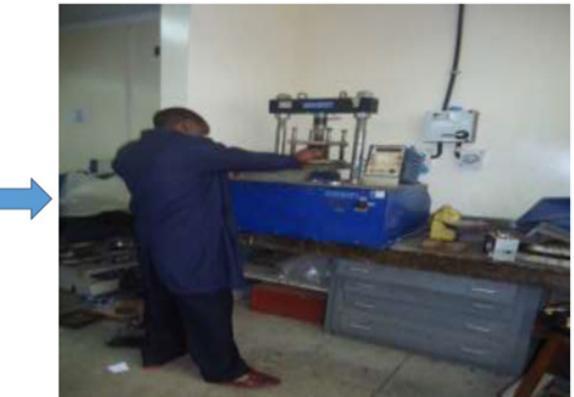
FIGURE 8a to f

a) Weighing of the BESM base material

d) Marshall Compacting at 75 blows

b) Mixing with water

c) Mixed material in 100mm diameter

ITS testing using Multi-Speed Tester

e) Oven curing of compacted material

Laboratory Procedures for Indirect Tensile Strength Test **Source:** Nzai, 2025

The field samples were subjected to laboratory testing and analysis. Subgrade, subbase and base materials were subjected to materials classification tests including grading to 0.075mm, Atterberg limits, compaction test using standard Compaction of 2.5 kg rammer for subgrade materials and heavy compaction of 4.5kg rammer for pavement materials, and California Bearing Ratio (CBR) and swell measured after 4-days' soak on samples moulded at 100% Maximum Dry Density (MDD) and Optimum Moisture Content (OMC). Further, BESM base material was subjected to Indirect Tensile Strength (ITS) testing (both dry and soaked ITS), grading modulus (GM) test and binder recovery (residual binder) test and emulsion content test to assess its performance under the current traffic loading and prevailing climatic conditions. ITS test was conducted in accordance to the procedures outlined in AASHTO Designation T 283-89: Resistance of Compacted Bituminous Mixtures to moisture induced Damage. Two sets of the collected BESM base material were thoroughly mixed with water, placed in 100mm diameter moulds and compacted at 75 blows using the Marshall compactor. One set of the moulded specimens was oven cured at 40 degrees for 72 hours, then crushed for ITS dry testing. The other set was soaked in water for 24hrs at 25 degrees Celsius for determination of soaked strength (soaked ITS). **Figures 8 a to f** shows photographic illustration of the laboratory procedures.
