# Geophysical investigations of Suyien Earthdam in Maralal, Samburu County, Kenya

The Current economic and population growth has increased the water supply gap in Maralal, Samburu County. Water sources include boreholes, pans and the Suyien dam. Despite the high rainfall in the area, Suyien dam has never filled since its construction in March 2010. This study investigated the geological factors hindering the dam's impoundment of water. The aim was to determine the characteristics of the subsurface compromising this process. A desk survey of existing geological and hydrological reports as well as topographic and geological maps was undertaken. Analysis of laboratory tests, aerial photographs, electrical resistivity and trial pits was done. Results showed that the topography, dotted with several sinusoidal hills comprises Mozambiquan rocks, igneous intrusives, and Paleogene-Quaternary volcanics and sediments. Neo-Proterozoic and volcanic formations had surface joints and fractures implying secondary porosity and permeability. Hydrogeological information showed boreholes sited near rivers or laggas, yield about 1.4-2.5 m<sup>3</sup>/hour and about 4 m<sup>3</sup>/hour in volcanic roc

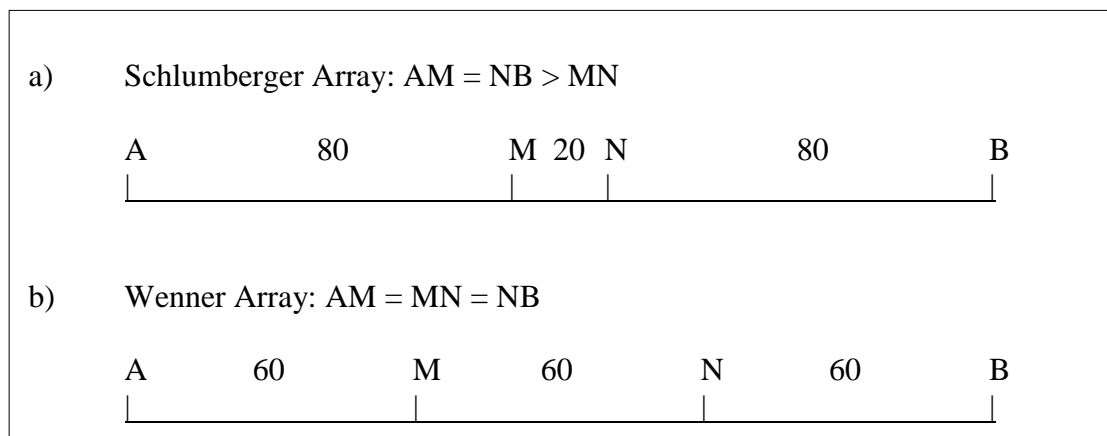
**Figure 3: Schlumberger and Wenner Configurations for Resistivity Measurements (AB = current electrodes and MN = potential electrodes).**

The measuring setup consists of a resistivity instrument (usually placed in the middle of the array), connected to two current electrodes (AB), and two potential electrodes (MN) towards the center (Fig. 3). When carrying out a resistivity sounding, an electrical current ( $I$ ) is passed into the ground through two metal pins, the copper electrodes.

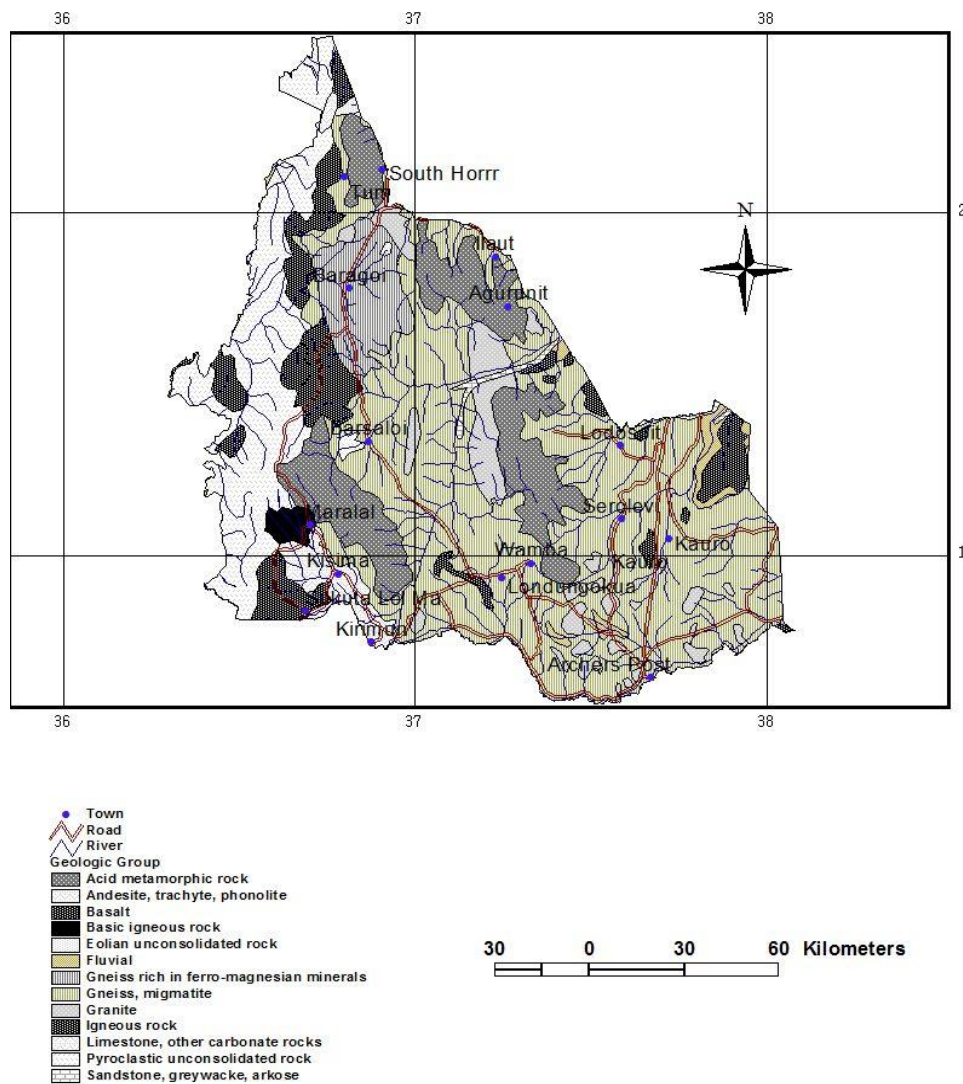
**Figure 1: Lithology of Samburu County. The eastern part is covered mainly by gneisses and migmatites while younger volcanic and sedimentary successions cover the western part.**

The undulating topography dotted with several sinusoidal hills reflect the general geology of Samburu County. The area stands at an average altitude of 2051m a.s.l. within a steep-dipping terrain punctuated with several ant hills and flood plains both on the south eastern and north western flanks. The County lies on the eastern shoulder of the Rift Valley and can be subdivided into two major geological divisions. The eastern side covered mainly by the Mozambiquan rocks interspersed with occasional igneous outliers which occupies roughly two thirds of the county. The western side constituting one-third of the county, on the other hand, is covered by basic lava of Paleogene-Neogene volcanics of the rift valley (Fig. 1).

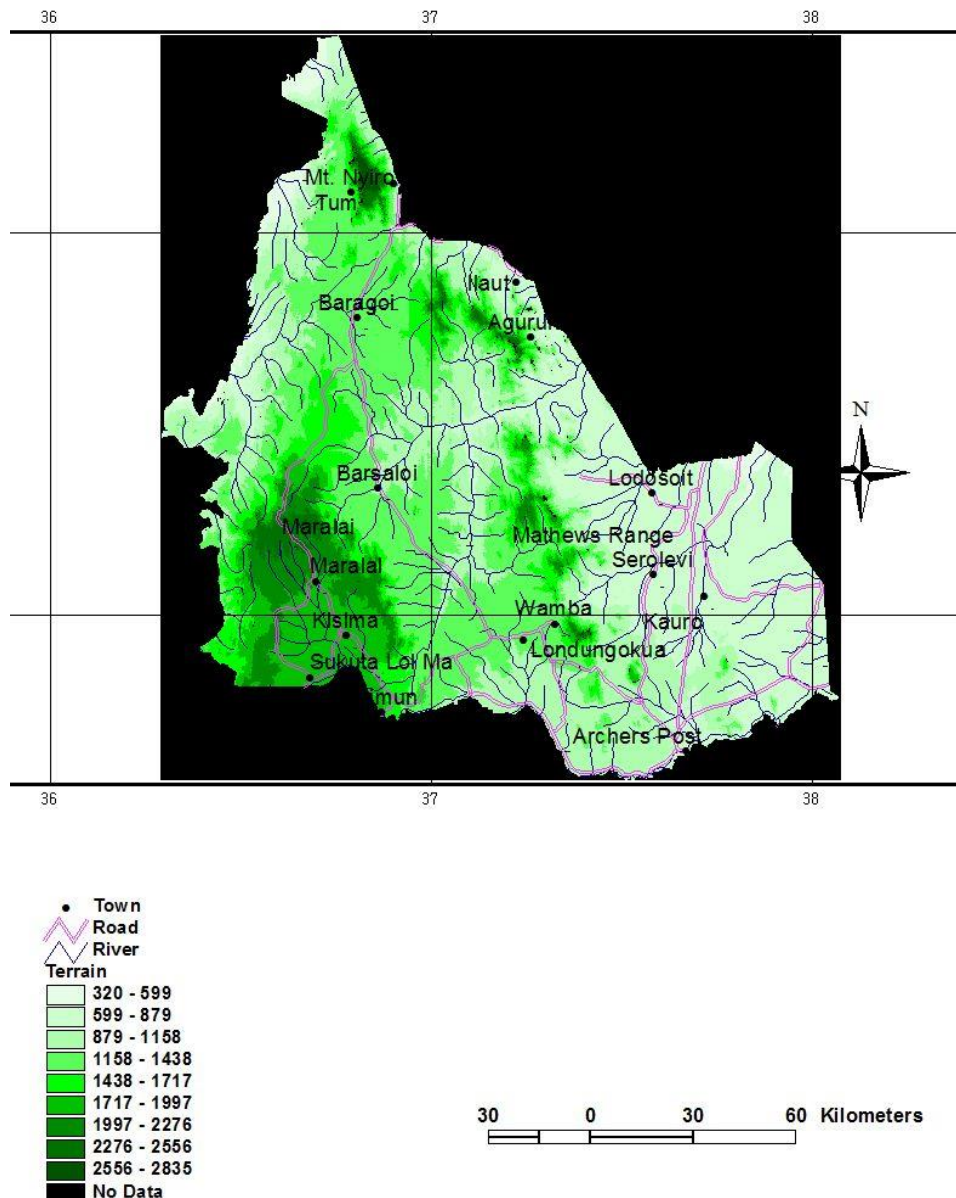
**Figure 2: Major Relief Features of Samburu County. Note the drainage divide indicated by easterly and westerly flowing rivers. The central and western parts of the area are the highest (>1700m).**

The relief of the county has a north-south ridge on the flanks of the Rift Valley running from Mount Nyiro Ndoto (2752 m.) through Baragoi, Maralal (2531 m.) and Suguta and another ridge on the east running from Aguru, Mathews Range and Wamba (2688 m.).The ridges form the major drainage divide (Fig. 2).

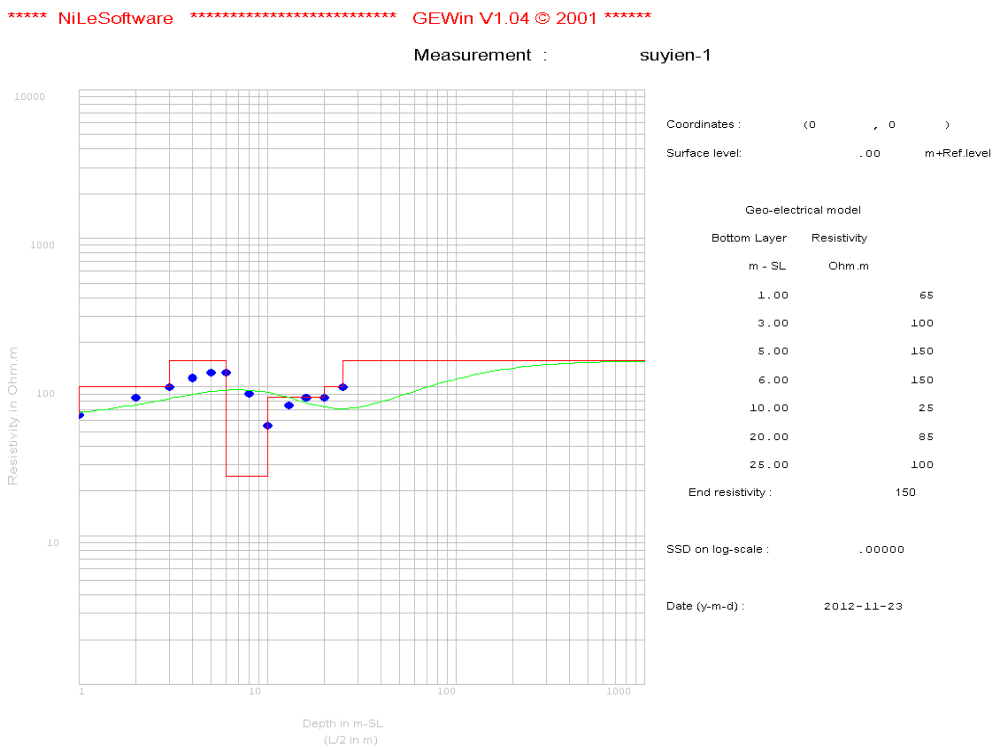
**Figure 4: Vertical Electrical Soundings for Site 001/2012. The red and blue curves depict relation of AB/2 and the apparent resistivity with the blue curve showing resistivity variation. A comparison with computer generated curves and the goodness of fit is as shown.**

The geological sequence and hydrogeology of the area were used to interpret the resistivity measurements (Figs.4-10). The crystalline rocks and volcanics are heavily fractured and lineaments could be detected on the surface. The laggas also follow fractures implying high water infiltration. Table 2 shows that groundwater in Mozambiquan rocks was reached after drilling between 24 m and 40 m while in Paleogene-Neogene rich aquifers were reached at 80 m. The areas of colluvium, alluvium and lacustrine sediments formed high groundwater at less than 2m. The types of rock formation in Table 3 have been based on field evidence along dam banks and eroded gullies, geological and geohydrological information.

Table 3 shows the resistivity measurements for all the seven sites considered. The expected geological formation is dependent on whether the resistivity curve is rising or falling and may not be represented adequately by the absolute resistivity value. The rising limb of the resistivity curve points to fresh gneisses while the falling limb of the resistivity curve points to fractured or weathered geological formation.

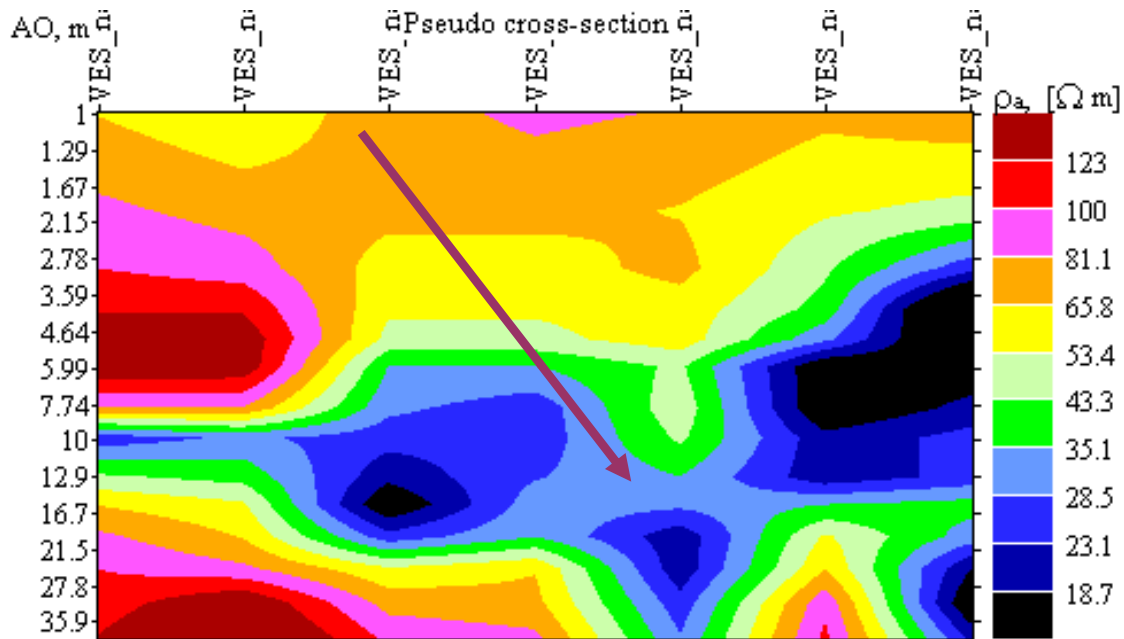
The TIs provide a 2D (depth-horizontal) comprehensive picture than 1D probes and are shown for sites marked TMGR-01 to TMGR-07. The structures at the floor of the dam demonstrate water seepage from dam floor (Fig. 11).

**Figure 11: Tomographic image of the bottom of the Suyien dam Site TMGR-01**

Colorful layers are a representation of resistivity value distribution from seven interpolated VES data. From the above tomographic profile (Fig. 11), it is readily noted that there is a fractured/weathered zone comprising the brownish laterites at the floor of the dam which channels the water to the bluish cross section comprising weathered/fractured zone. The water consequently seeps away from a depth of 3 m at site TMGR- 7 to the depth of 35.9m bgl at site TMGR- 5. Under the circumstances, there needs to be a water proofing material on the dam floor without further delay.

A fissure was identified at the center bottom of the dam which possibly allows water to seep through. Remediation measures such as water proof cement to seal off the dam floor cracks is recommended.

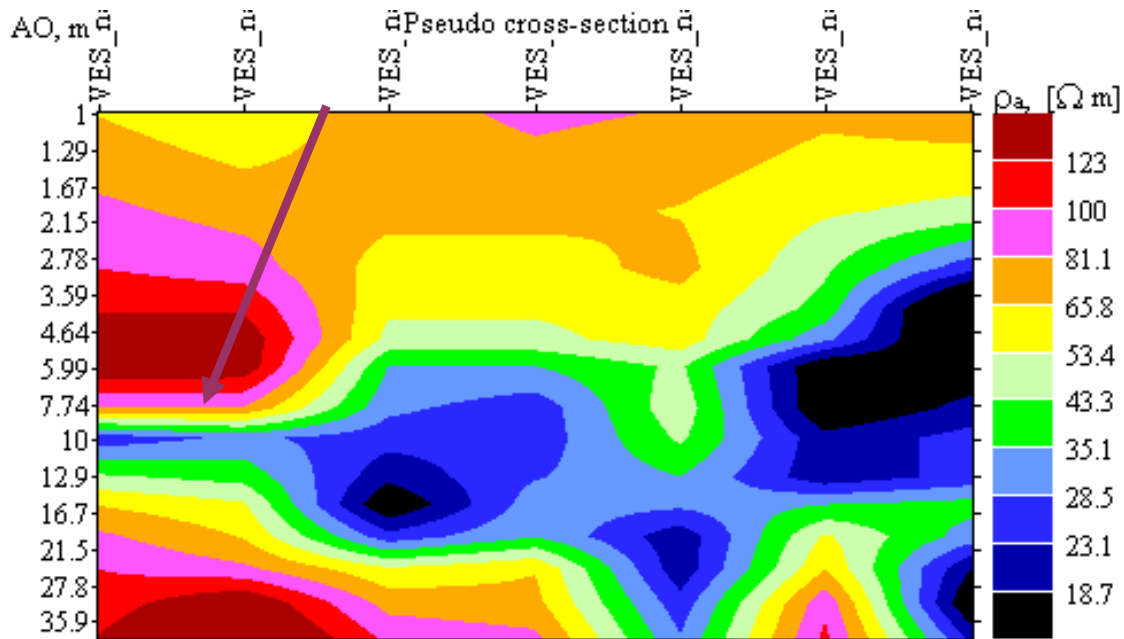
At zone VES TMGR-3 site in (Fig. 12) the brownish zone showing a fracture occurs in varying depths. The fractured zone begins from 0.1m to 3.0m of depth, meaning that the fracture has a thickness of 2.9m. Extending to 7.74 m as the arrow points out. High resistivity values indicates that water seeps through the fractured zone.

Figure 12: Tomographic image of the bottom of the Suyien dam Site TMGR-03

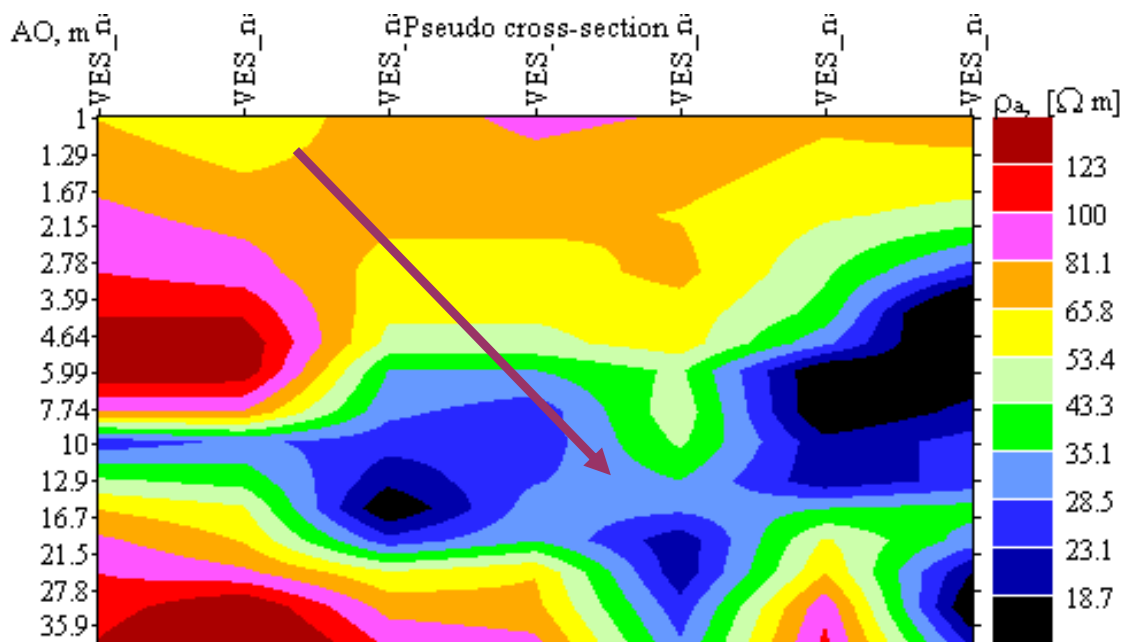
At zone VES TMGR- 5 sites (Fig.13), the fractured zone begins from 0.1 m to 3.9m, meaning that the seepage fracture at this point on the dam floor has a thickness of 3.8m bgl.

Figure 13: Tomographic image at Site- TMGR-05

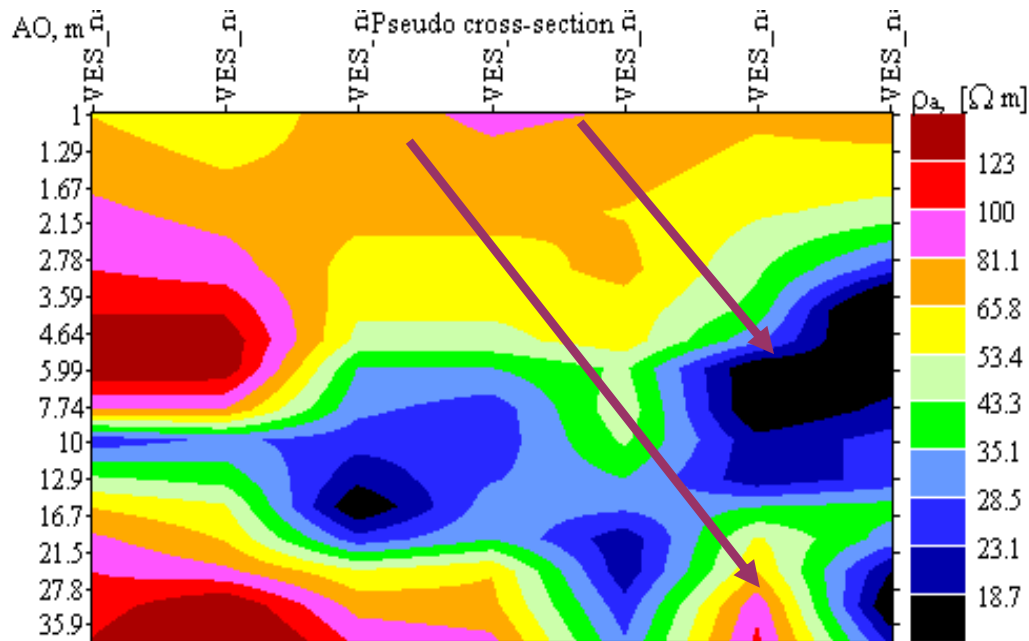
The bluish zone, occurring in varying depths, and which is probably weathered gneisses, is where the seeping water flows into. At zone VES TMGR-7 site (Fig.14), the ‘reservoir’ zone occurs in two distinct portions, namely from depths 3 to 13m below ground level (bgl) and as from 21 to 35m bgl, giving the respective seepage ‘reservoir’ thicknesses at these two points on the dam floor as 10m and 14m bgl. However, at zone VES TMGR- 7 spot, the thickness of the laterites is 0.1 to 1.2m bgl.

Figure 14: Tomographic image at Site TMGR-07
